## Minor Surface Dimples & Rippling of PVC Pipe

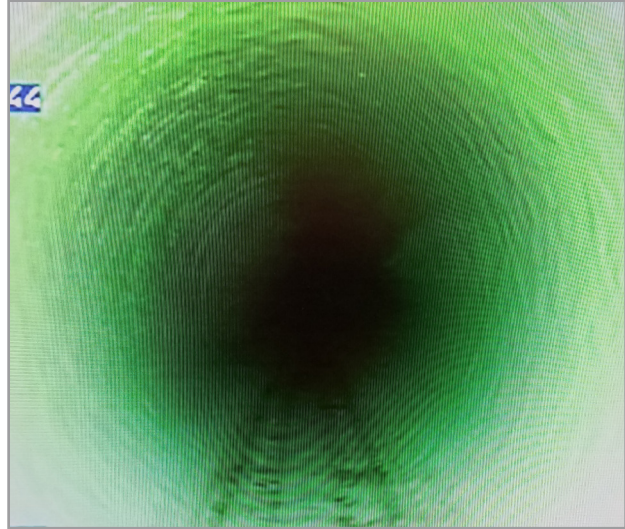
These features however do not adversely affect the structural integrity of the pipe wall or the pressure capacity of the pipe, and have negligible effects on the flow efficiency of the pipe.

Acceptable rippling on the inside diameter of 8" ASTM D3034 PVC Gravity Sewer Pipe

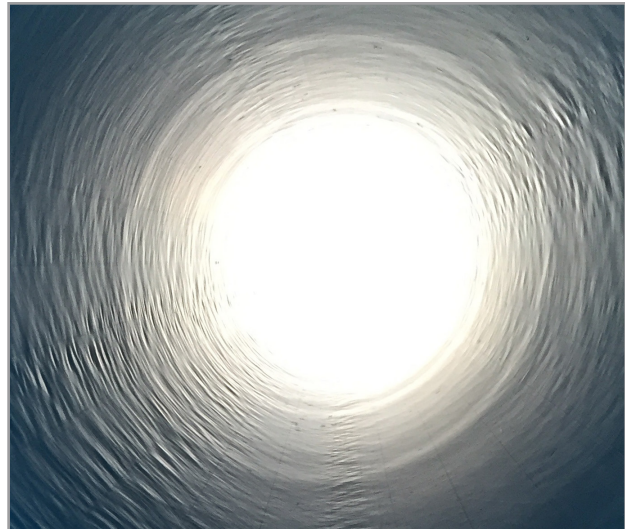
Acceptable rippling on the inside diameter of PVC pipe under natural lighting conditions
